# Manhole Inspection Summary

Manhole # S31GG\_012MH

Insp Date: 1/15/07 12:15 PM

**Location** Address: **1303 BOLTON ST**

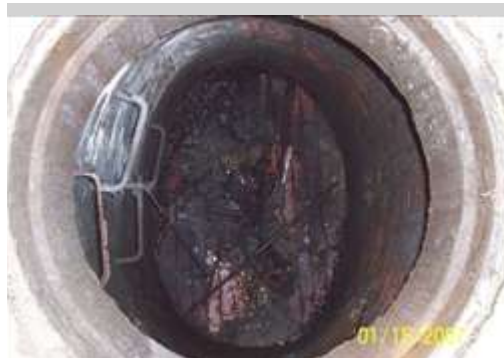
Top View

Corroded steps. Channel debris.

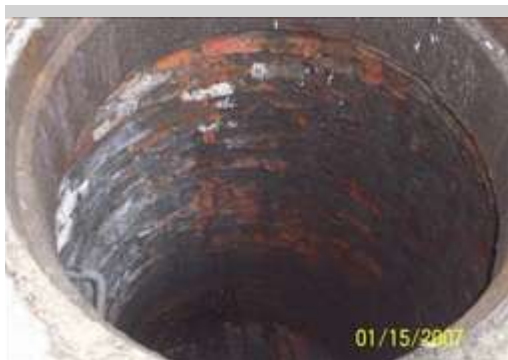
Defect

Frame leaks. Adjustment deterioration and infiltration. Corbel and Barrel infiltration - other side.

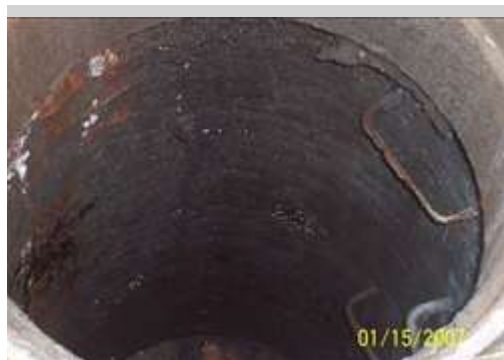
Defect

Frame leaks. Adjustment deterioration and infiltration. Corbel and Barrel infiltration.

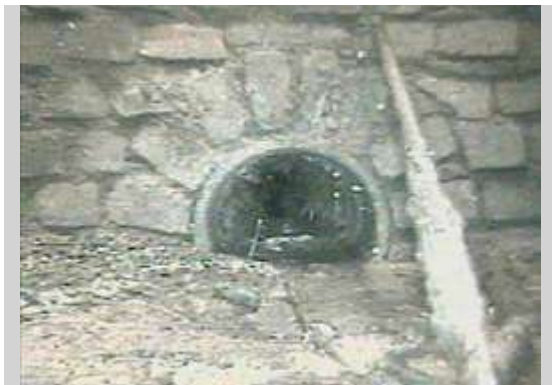
Pipe Out @ 12 O'Clock

Deposits: ☐ None ☒ **Mud** ☐ Sludge ☒ **Debris** ☒ **Grease**

Silt Depth: **1** (in.)

Deposits Extent: **Light**

Infiltration: **Evidence**
